**Bourne Bridge
Cape Cod Canal
Bourne, MA**

October 1992

INSPECTION REPORT

BOURNE HIGHWAY BRIDGE

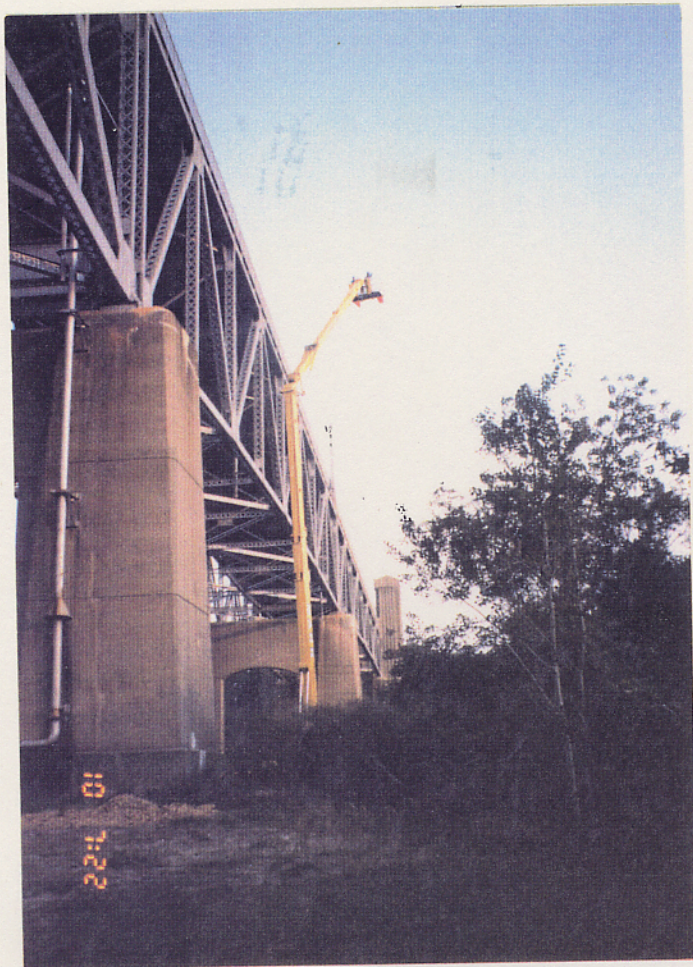
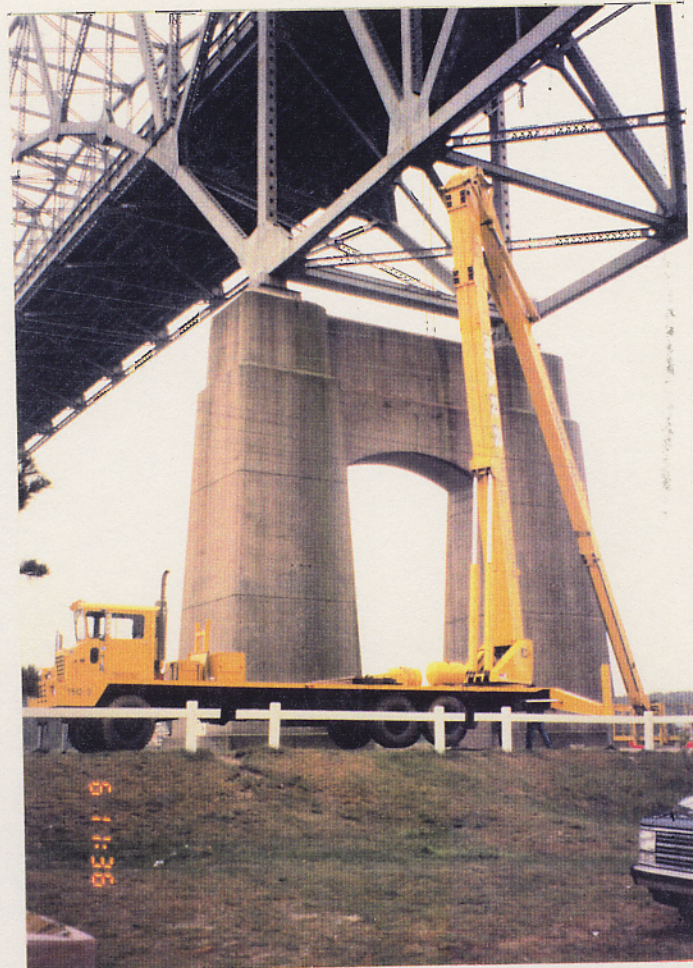
Truck-mounted aerial platform (Condor 150) in various locations, accessing underside of Bourne Bridge.
